Pre-Buy Inspection Report N [REDACTED]

CESSNA 172H SN: [REDACTED] Tach: 3139.3 ATT: 4536.6*
ENGINE: TCM O-300-D SN: [REDACTED] TTSN: UKN SMOH: 606.6* / 23 Years
PROPELLER: McCauley 1C172/EM7651 SN: [REDACTED] TTSN: UKN TSMOH: 588.2

This report represents the findings of a pre-buy inspection performed at KAJO on 12/22/2020. Information was obtained through a physical inspection of the aircraft and logbooks provided by the owner.

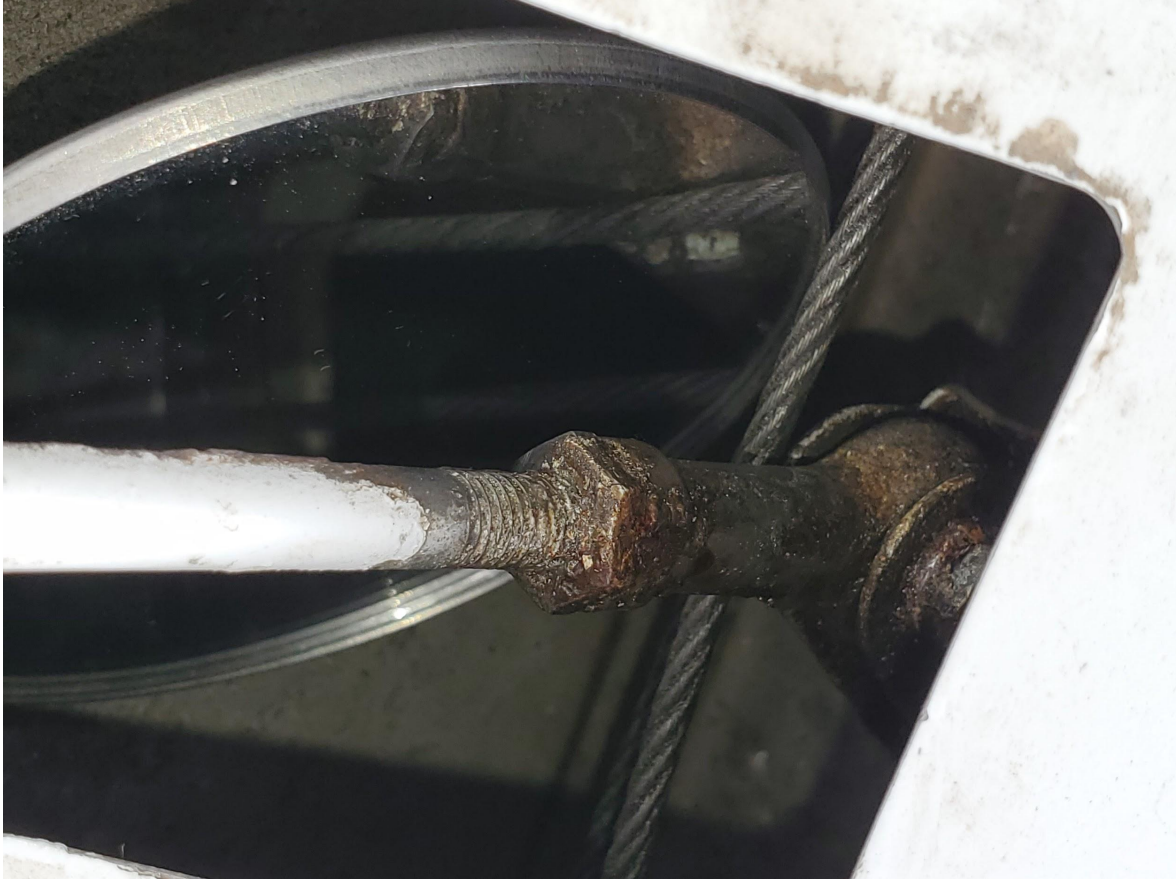
- Left, upper inboard and upper outboard flap rollers are worn beyond limits
- Left aileron cable rubbing on top of rod end of flap push rod
- Cargo door misaligned with airframe

Aileron Cable Rubbing on Flap Push Rod

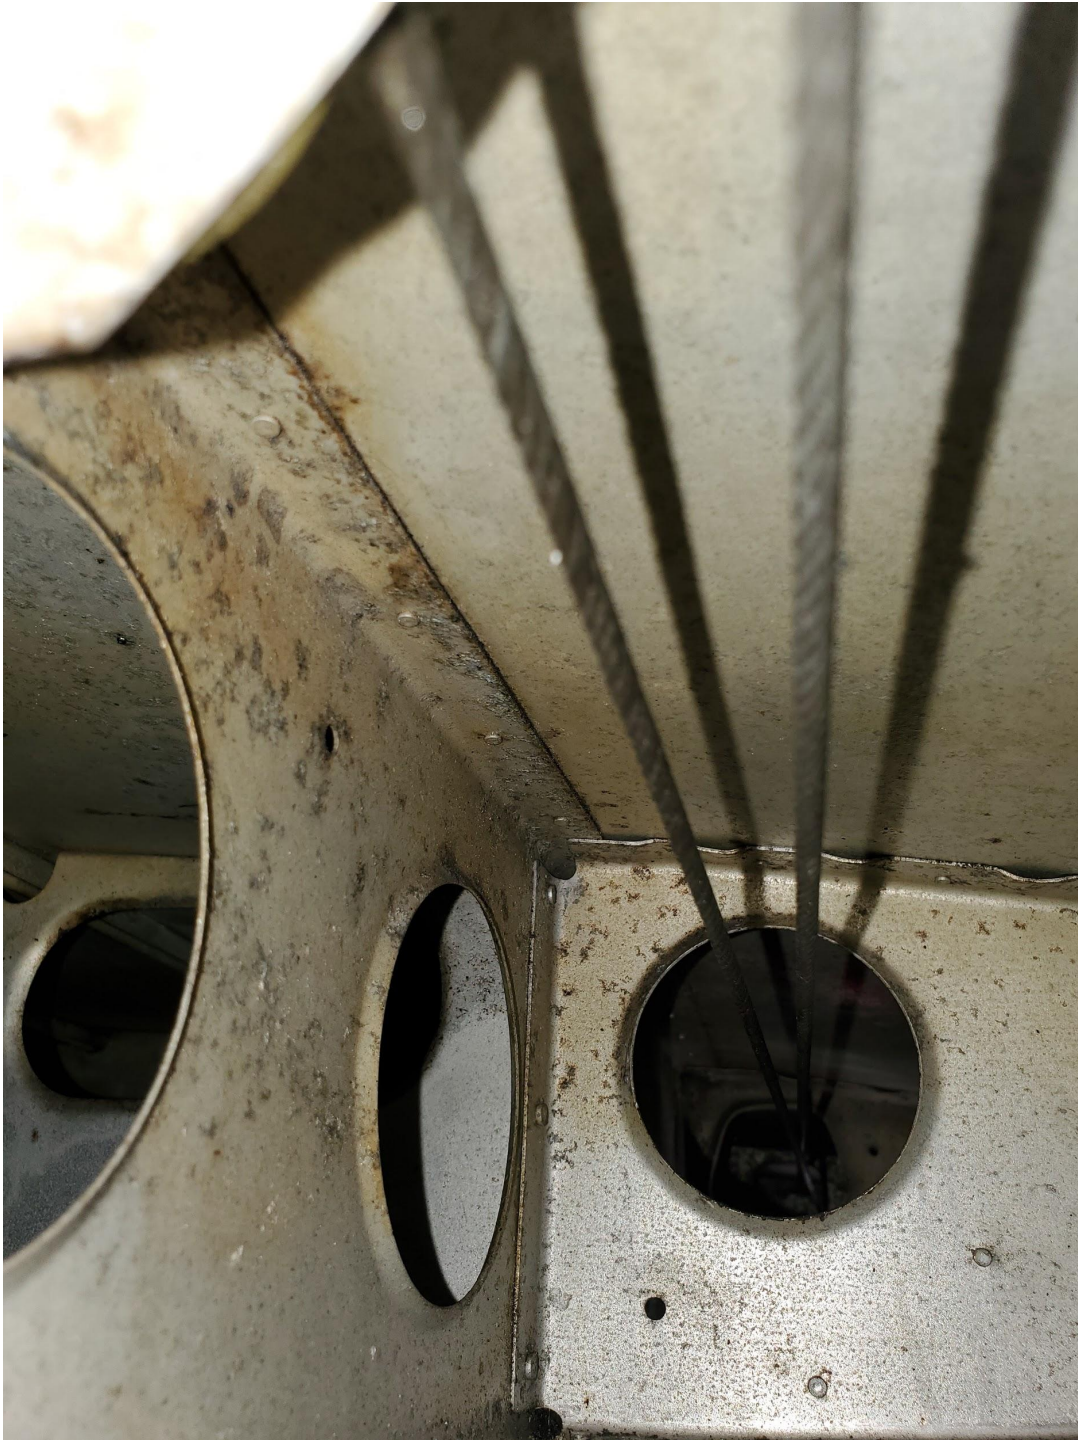
- Established surface corrosion in left and right wings. Light surface corrosion noted in empennage. The existing corrosion is typical of this vintage aircraft and is not currently an airworthy item. Recommend corrosion treatment going forward.

Established Corrosion in Left Wing (Right Wing Similar)

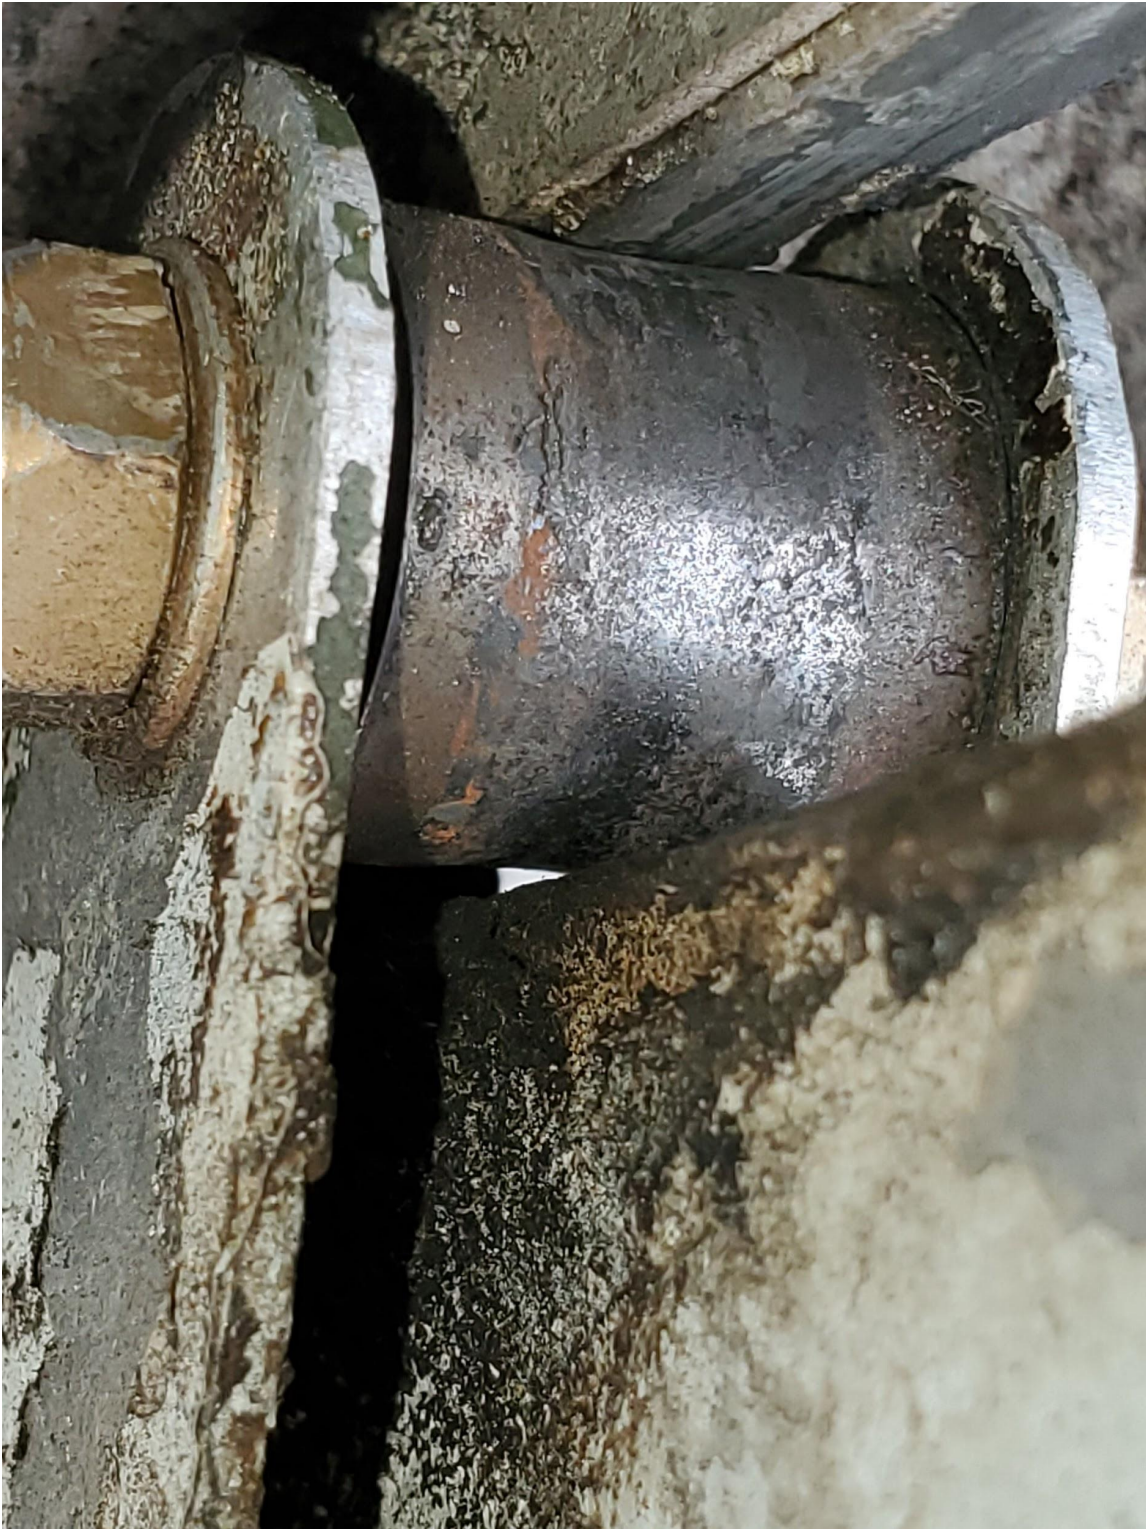
Flap Roller Worn

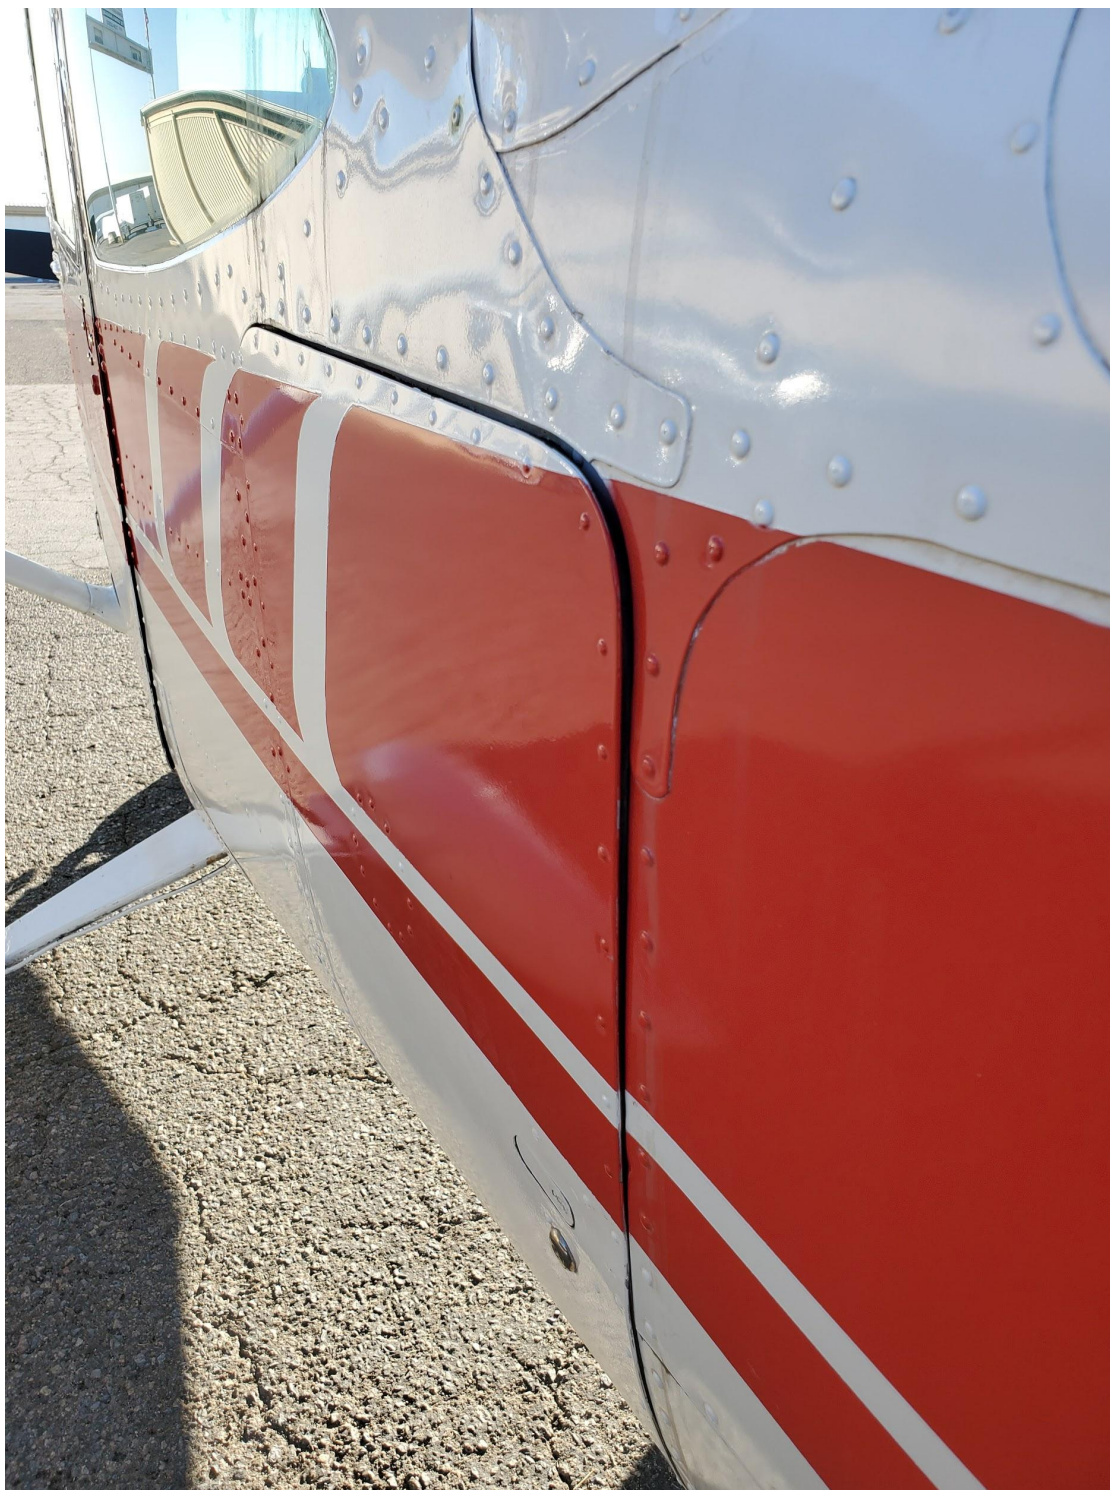
Cargo Door Misaligned

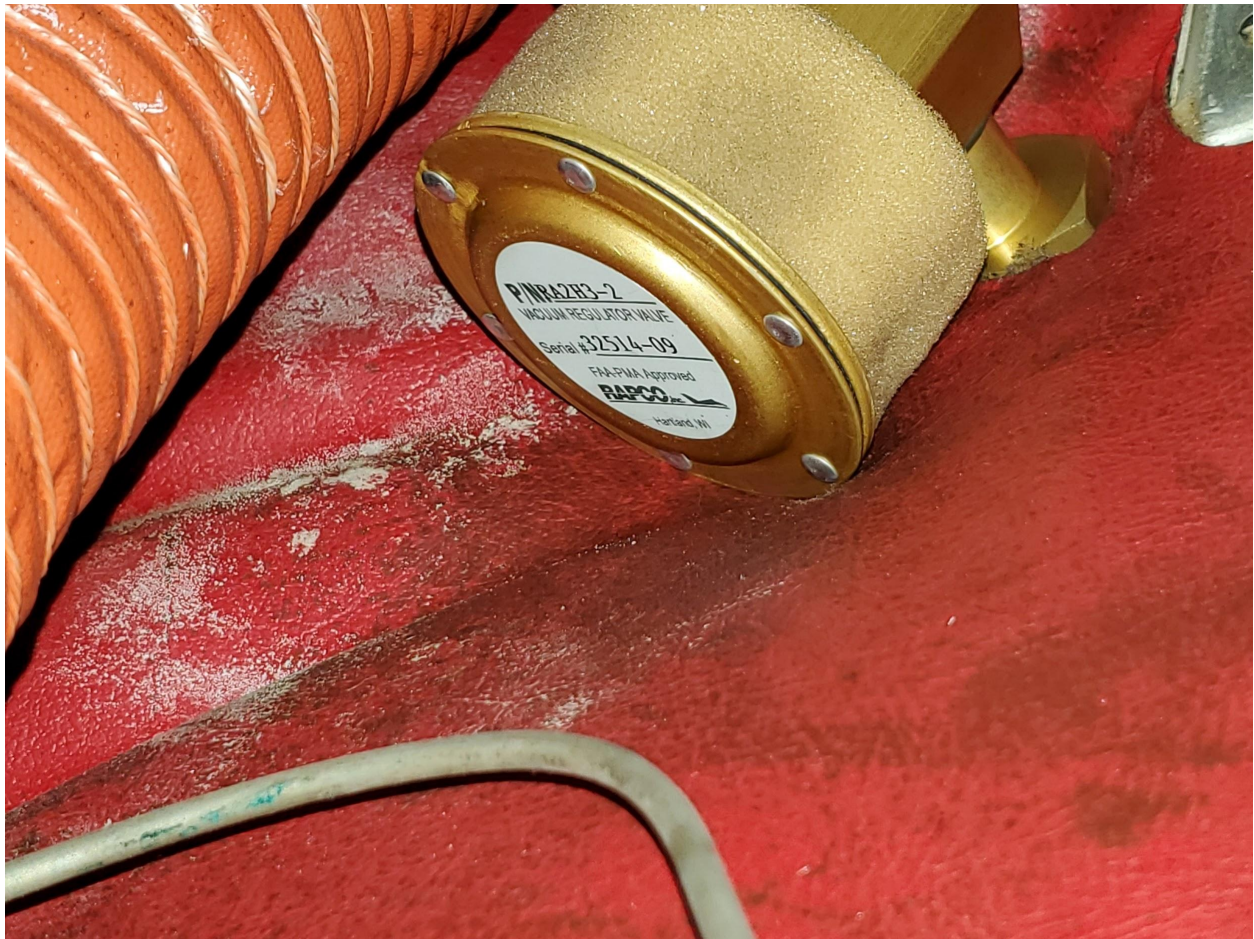
- Airframe logbook entry dated 1/24/2018 is illegible
- Garter filter excessively dirty. This annual item has not been replaced in several years
- Instrument filter dated "3-24." An annual was performed on 3-24-2011. These filters have a 500 hour or five year service interval, whichever occurs first

Garter Filter (Should be changed annually)

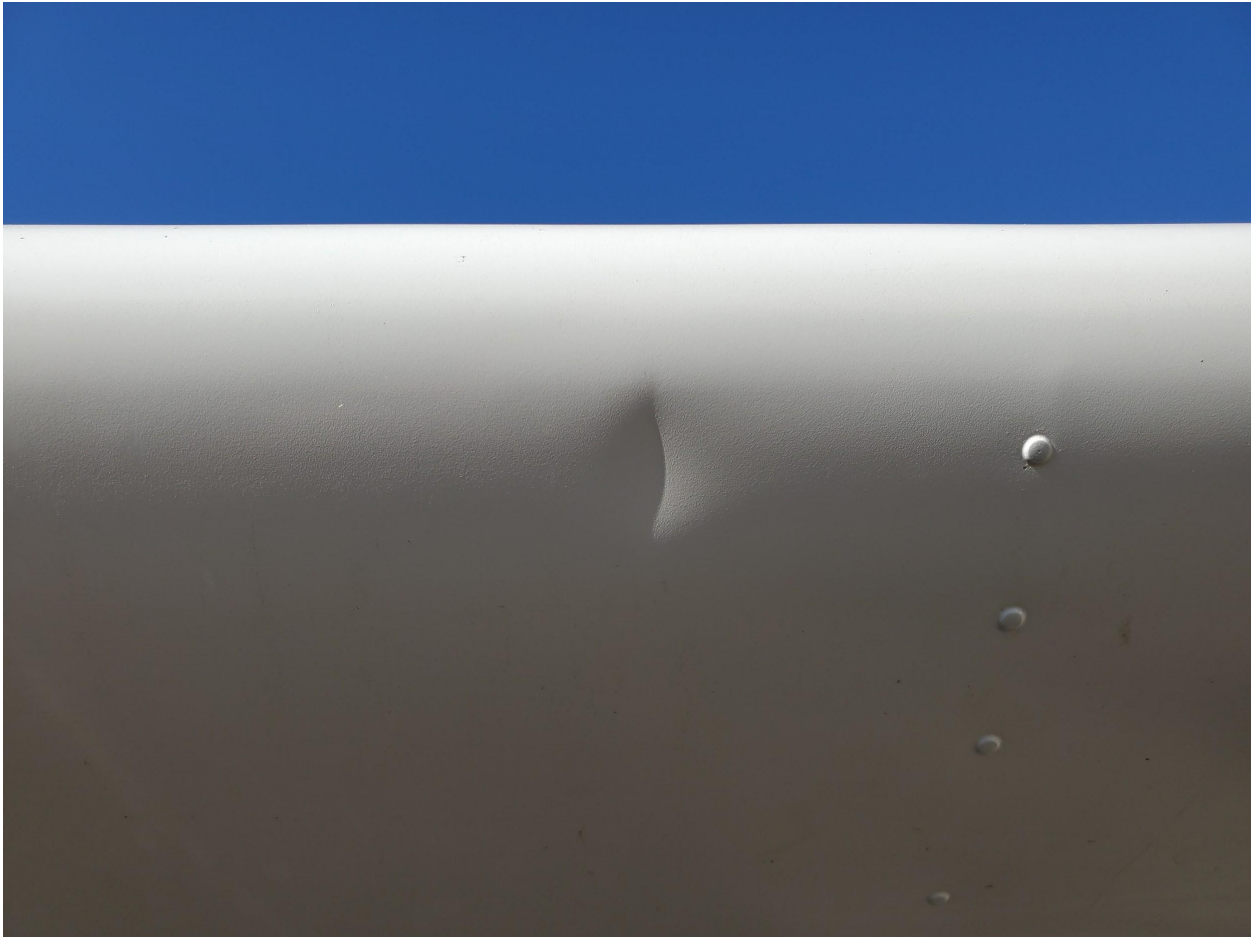
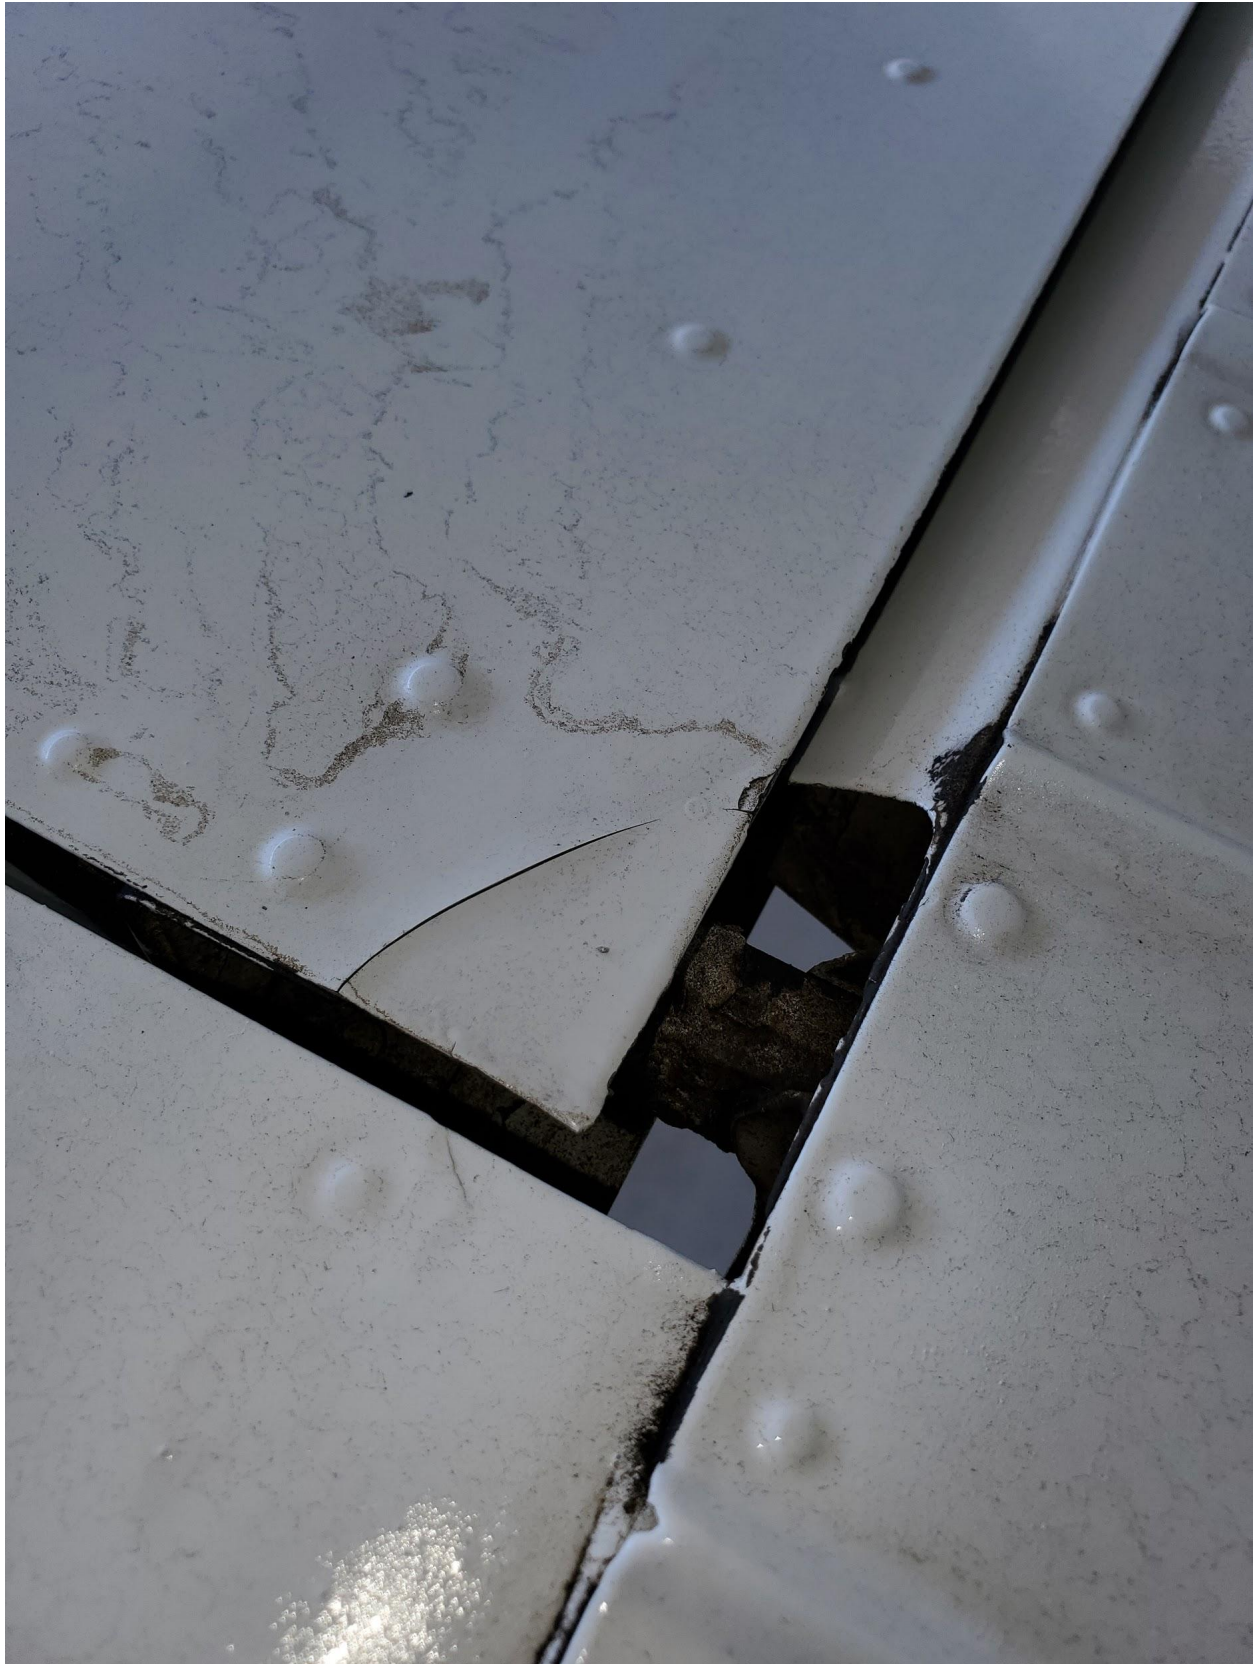
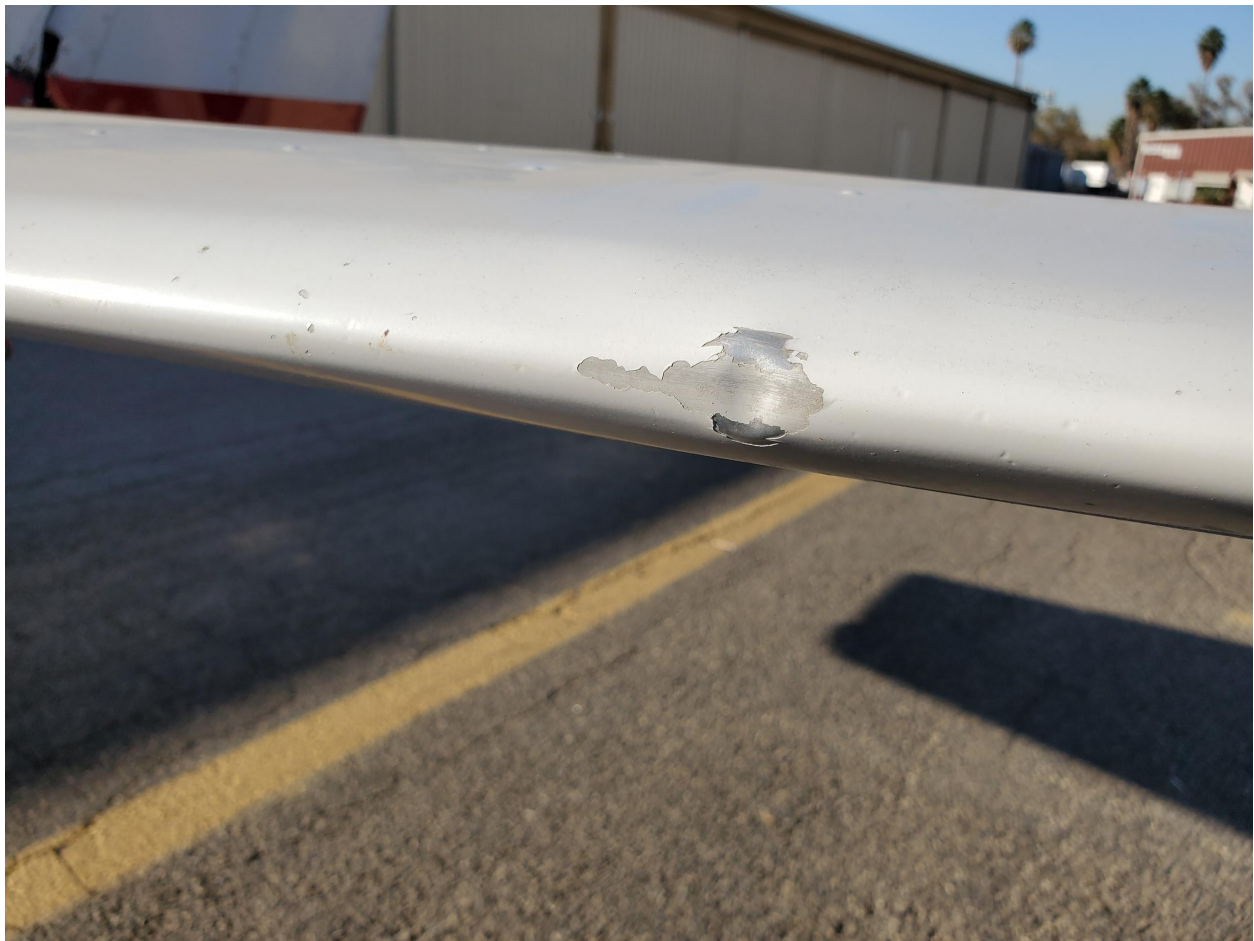
Various dents and damage noted throughout ("hangar rash")
