## Pre-Buy Inspection Report [REDACTED]

AIRCRAFT: 1980 Cessna T210N SN: [REDACTED] Tach: 2882.4 ATT: 2882.4  
ENGINE: Continental TSIO-520-R SN: [REDACTED] TTSN: 2882.4 SMOH: 1258.9  
PROPELLER: McCauley D3A34C402 SN: [REDACTED] TTSN: 2882.4 TSMOH: 1079.4

This report represents the findings of a pre-buy inspection performed at KRAL on 02/25/2021. Information was obtained through a physical inspection of the aircraft and logbooks provided by the seller.

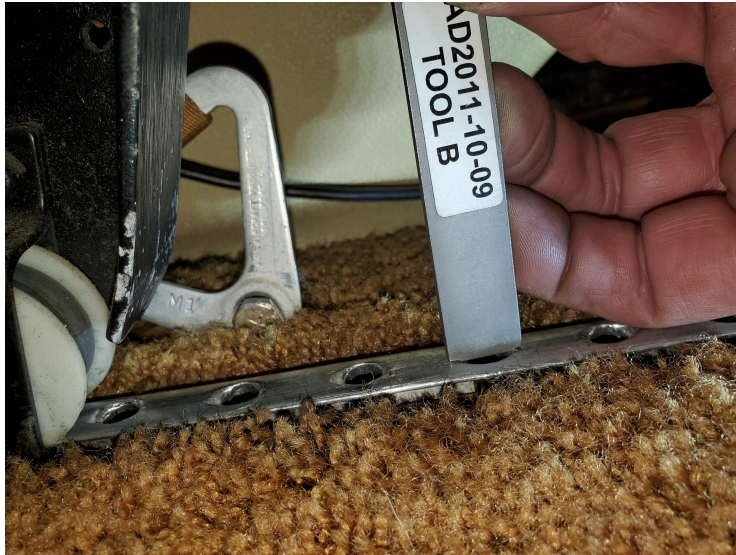
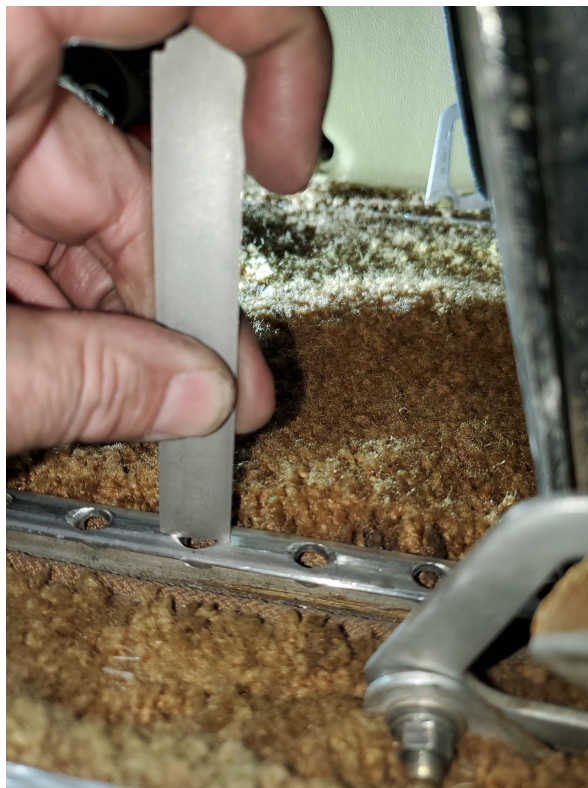
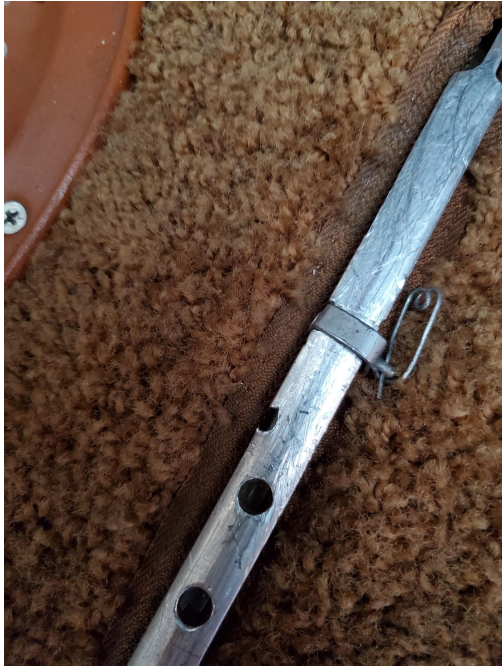
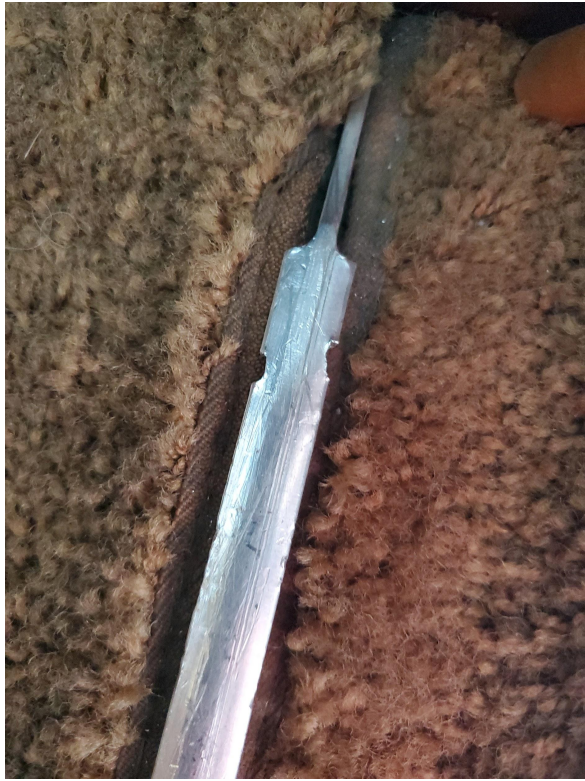
**Pilot and copilot seat rails**

- Pilot outboard seat rail and copilot inboard seat rail exceed wear limits defined in AD 2011-10-09 Par. (g)(3)(i). Did not inspect other parts targeted in the AD

- Pilot outboard and copilot outboard and inboard seat rails show damage in forward section
- No record of compliance with AD 2016-16-12. While there is no maintenance record of ECI cylinders being installed, the existence of undocumented maintenance and installations suggests further investigation (specifically a physical inspection of the cylinders as outlined in Par. (e)(4) of the AD) is required before confidently addressing the disposition of this AD

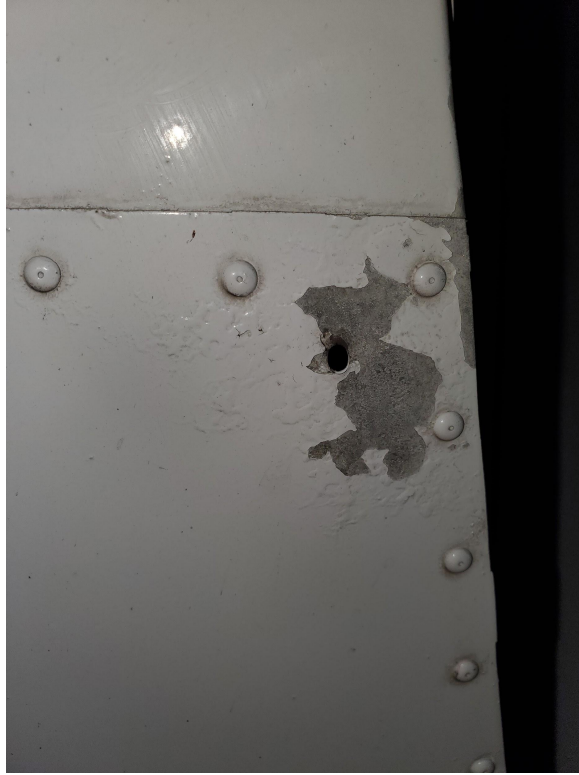
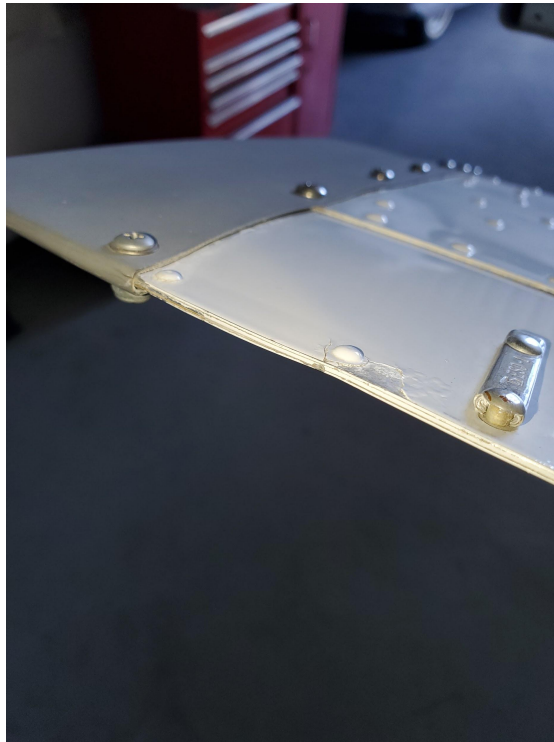
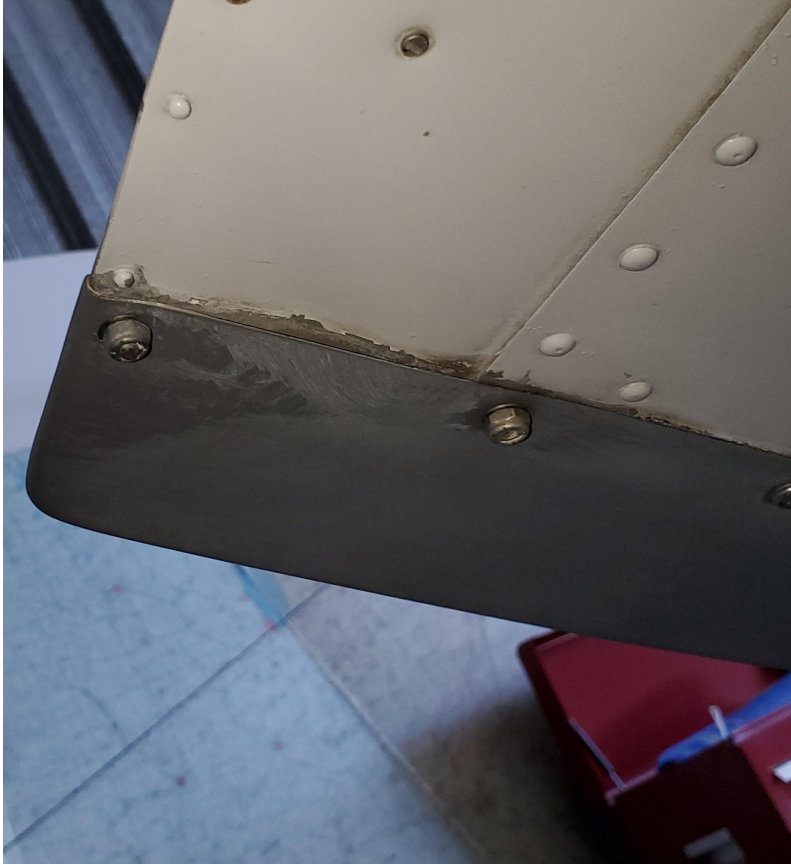
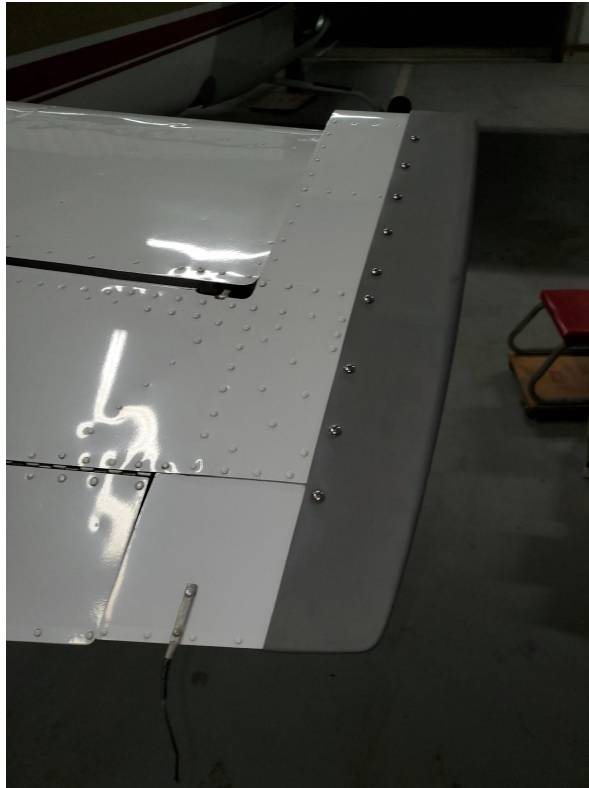
**Elevator corrosion and wingtips**

- Light surface corrosion noted throughout wings. Established surface corrosion noted in left and right bulkhead areas near wing attach bolts. Surface corrosion noted in left, IB and OB elevator tip. Existing corrosion does not appear to be an airworthy item. Recommend full aircraft corrosion inhibitor treatment at next annual

- Factory installed foam inside elevators still present. Only evidence of slight corrosion observed on the exterior surfaces
- Metal nose gear spring guide installed. No record of installation

- Unpainted, plastic elevator tips installed using lock nuts. No record of installation or elevator balancing subsequent to installation
- Ducting beyond repair in various locations, but notably under copilot side panel and left and right aft cabin bulkhead (rear seat air vents)

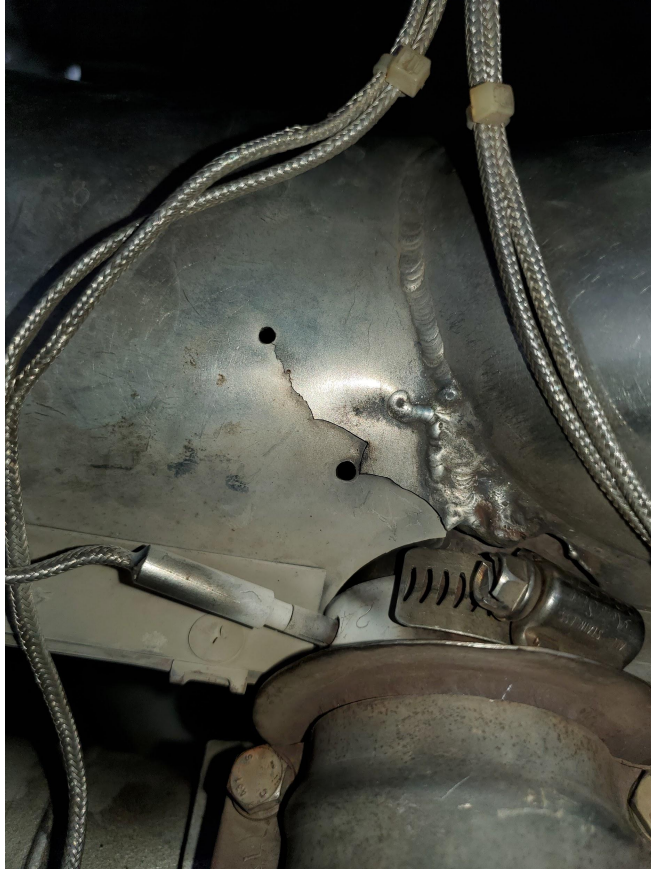
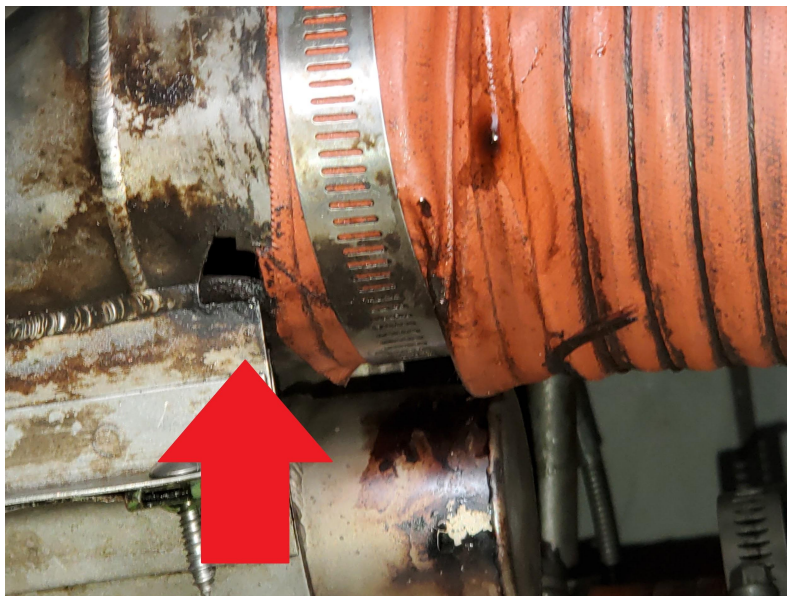
**Heat muff cracks**

- Presumably unapproved repair on induction tube aft and below of #1 cylinder
- Right brake rotor warped, left brake rotor presents with noticeable lip
- Cracks present on heat muff

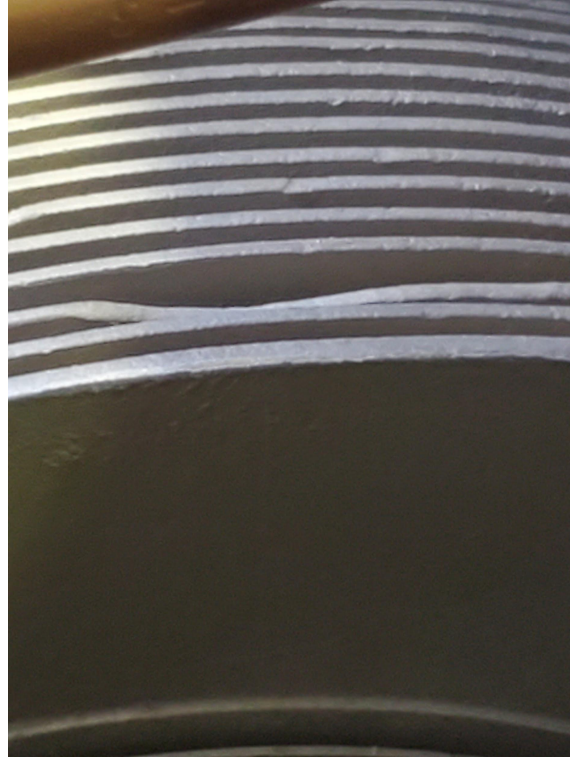
**Damaged fin #1 cylinder**

- Flatspot present on right MLG tire
- Damage to cooling fins on top #1 cylinder
- Play evident in cowl flap doors, suspect hinges
- Evidence of oil leaks throughout engine, typical of this vintage, but most noticeable below #6 push rod tubes. Engine is otherwise notably clean

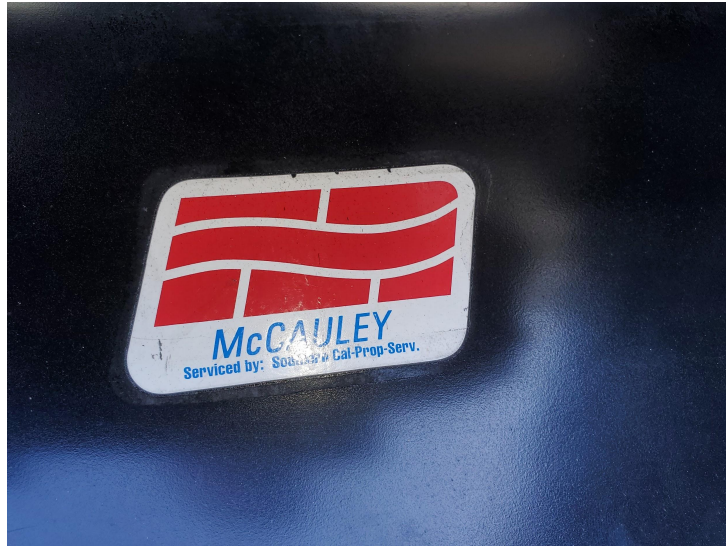
**McCauley Sticker on propeller blade**

- No record of compliance with propeller AD 2005-14-11. Stickers on propeller indicate most recent OH performed by Southern California Propeller Service

- Propeller manufacturer's recommended calendar TBO time has been exceeded by 19 years per McCauley SB137W dated 5-15-2002, Note 4. Hourly TBO time due in 920.6 hours
